# Earthquake in Pakistan

## **An Assessment of Environmental Risks and Needs**

**Based on IUCN Field Missions to NWFP and AJK**  
November 19–26 and December 4–7, 2005

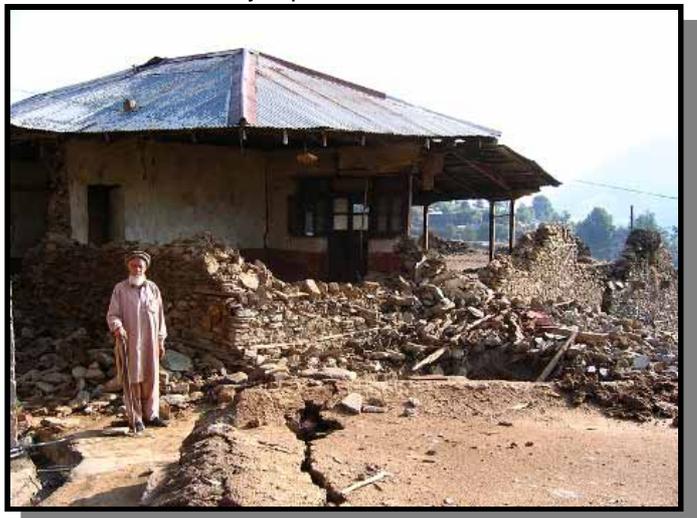
Huge losses in life and property were reported in the areas of NWFP which were visited. Landslides have occurred at many locations in the hilly areas. Most of these slides had not stabilized at the time the mission was fielded, as was especially observed in *Allai*, where the soil was still unsettled due to continued tremors.

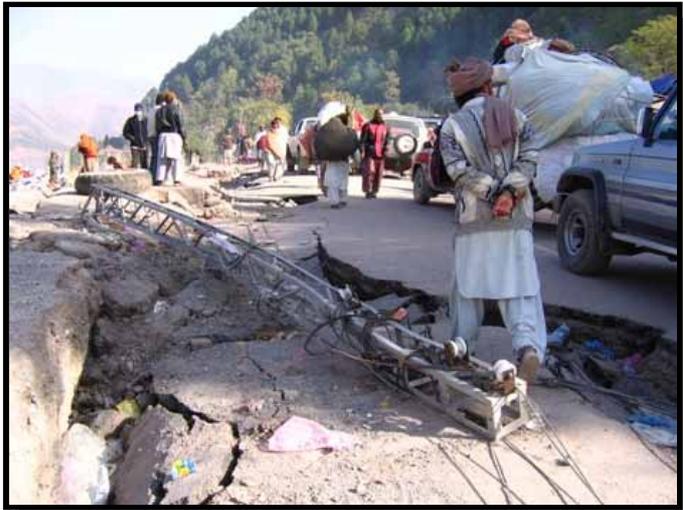
The basic damage to the physical environment in AJK was due to the massive landslides, throughout the affected areas. Their occurrence was the highest in and around the area of epicentre, *Muzaffarabad* and its environs. The slides

have caused huge damages to the infrastructure of the area, such as to roads, bridges, houses, public structures, and even heritage sites, such as the *Muzaffarabad* Fort. In most areas these slides have not yet stabilized.

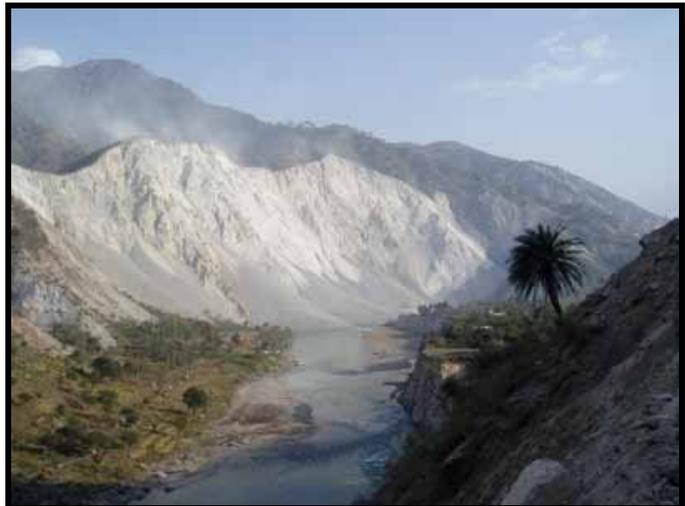
**Silt Load in rivers:** The rivers in the affected areas have received large volumes of sand, soil and stones from the landslides that occurred as an immediate consequence of the EQ. This has significantly raised the silt load in these water bodies, which will be transported downstream. This may not be apparent at the moment, and the material deposited in the water bodies may appear to have settled at present, mainly due to the low flow in the rivers.

However, as the volume of water in the rivers increases after rains, this silt may dislodge and be carried downstream. This will increase the rate of siltation of the *Mangla* reservoir, located near the town of *Jehlum* in Punjab further downstream on the River *Jehlum*.

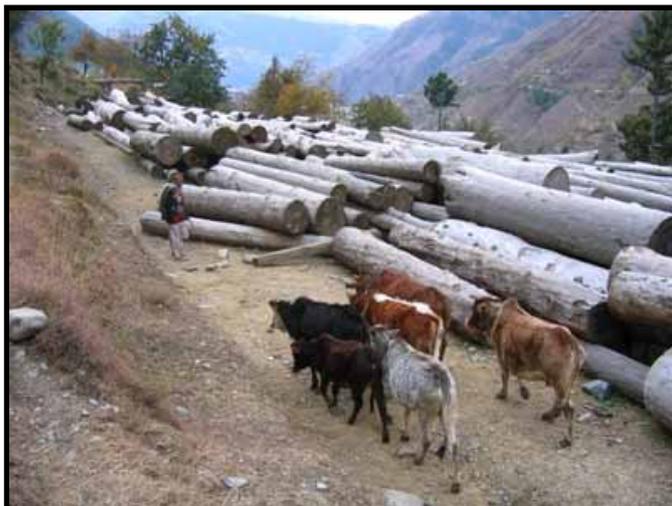
**Damages to Trees and Forests:** In the core area of the earthquake, standing forests on steep slopes were destroyed by landslides. Furthermore, many trees were damaged by rock falls. The earth shaking during the EQ was such that some trees simply truncated about two meters above the ground. The inner structure of many trees may have been damaged which would affect their use in future.

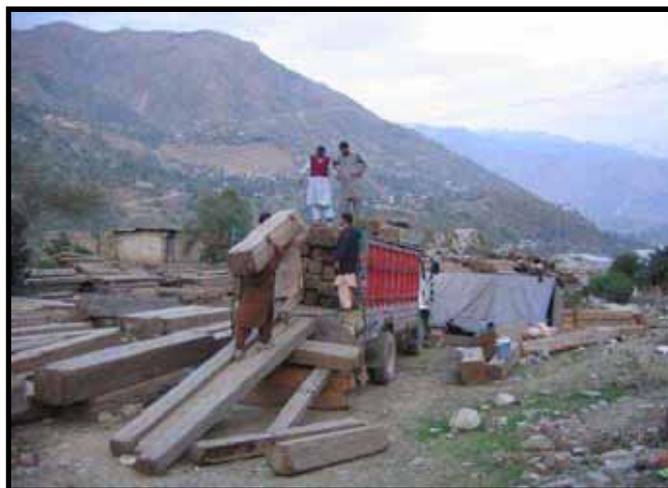
Another observation was made which also adds to the above, already high, risk. The timber stored in the affected areas is being transported out at an alarming rate for sale in high price markets in the lowlands. The Coordinating Officer in *Allai*, Col. Zakeer has placed a ban on the movement of timber out of the valley to reduce the need for cutting of trees for construction and other purposes.

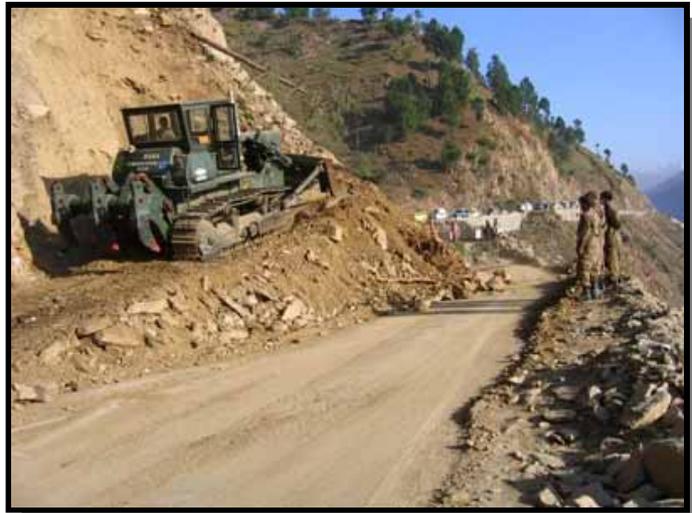
**Roads:** Due to the devastating EQ, many roads have been destroyed in the mountain areas of AJK and NWFP. The army did a great job in quickly repairing the main roads. Still, there are many link roads which have not been repaired, and it is difficult for the people living there to get the necessary relief items and material for reconstruction of their shelters and houses. The winter, with snow and rain and more landslides and mudslides, will again close many of these roads.
